# THICKENER PERFORMANCE OPTIMIZED WITH UPGRADE, SERVICES AND SUPPORT

## Strong partnership, services and support delivers optimised thickener performance, on-time and on-budget

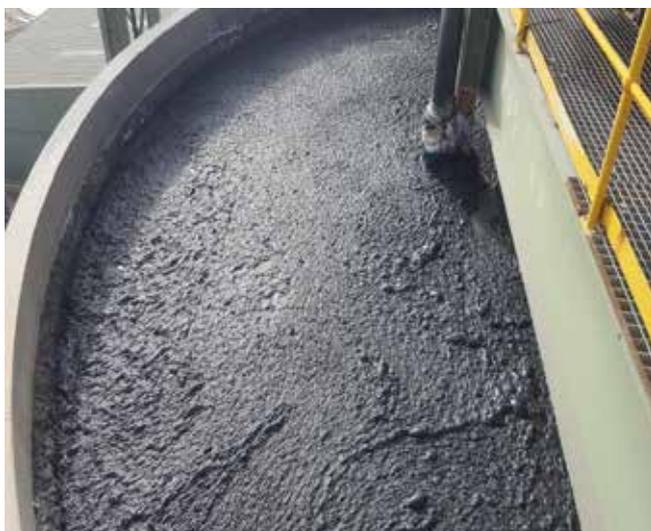
1. The froth would cover the entire surface of the thickener, before migrating to the thickener overflow launder. As a consequence, the froth would end up in the process water dam, where it would remain until the dam was dredged. Estimates suggest this froth was ~15% of the settled material in the dam, requiring recovery by dredging.
2. The froth was shown to contain gold, with assays suggesting the gold grade of the froth to be 12-15 g/t. Although the mass flow of the froth was small, it still represented deferred revenue.
3. The froth's presence in the overflow liquor impacted visual observations of the overflow clarity. Overflow clarity is used by operators in the decision-making process around flocculant addition.
4. The froth would occasionally cause erratic bed level measurements, also hindering efforts for correct flocculant addition.

Before - Thickener for free milling campaign

It was challenging for the material to report to the thickener underflow as it was naturally hydrophobic (analysis on the material revealed a sulphur content of 5-10%). Due to high feed velocities, air entrainment in the slurry was occurring initially in the feed box and the feedwell itself.

Following consultation with Outotec, it was decided that option 3 would be implemented, with froth booms also installed on the thickener rake arms, to encourage froth movement under the water sprays.

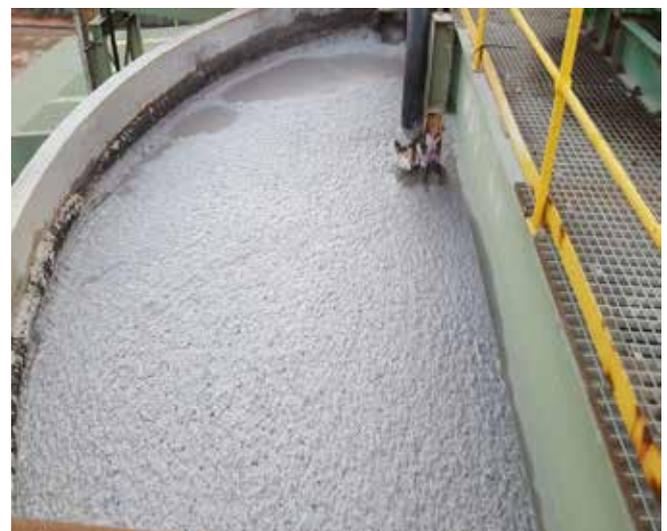
Before - Thickener for refractory campaign

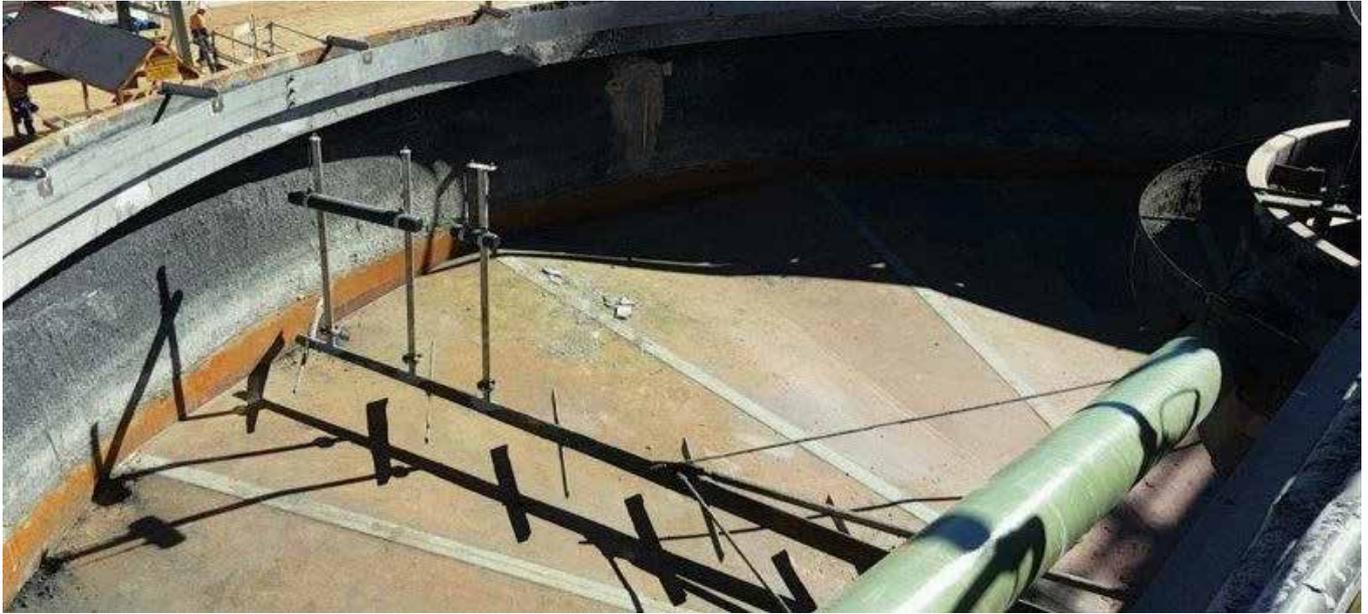
**Installation - Thickener after ring and boom**

The design of the froth ring and boom was somewhat complicated. The feed pipe sat relatively close to the thickener surface, with a flange in the feed pipe, with ~20 mm clearance from top of liquor. Ultimately, four booms had to be installed with allowances in one of the pieces of the ring to accommodate the feed pipe, without lowering the overall height of the froth ring. Also, the boom attachment to the rake arms had to allow for raising and lowering of the rakes.

The components were delivered onsite well prior to the shutdown, to help facilitate site's resource planning. The complete system was installed in May 2017 during a major mill shutdown, with Outotec onsite to provide advisory supervision. This helped ensure installation occurred trouble-free, within 2 x 12-hour shifts.

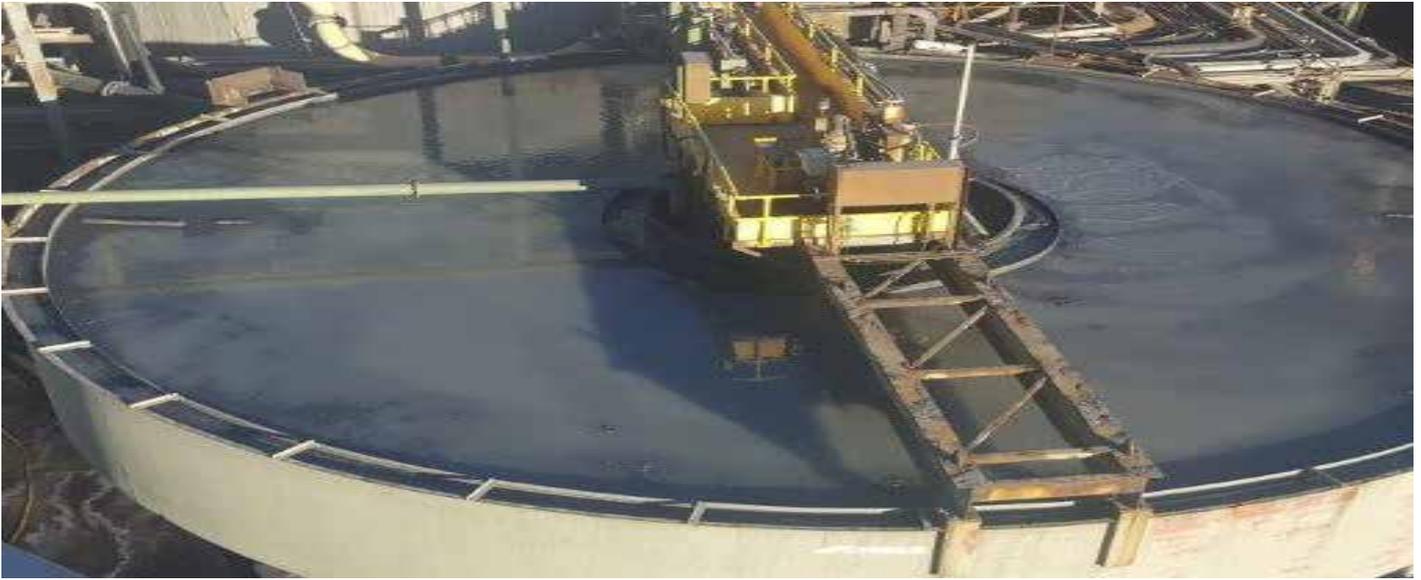
The froth ring and boom system has shown to be effective in its application, resulting in a high proportion of the material reporting to the thickener underflow stream on two of three free milling ore sources. The results are also visible in the first leach tank, which now has froth build-up on its surface, due to some of the material interacting with the gaseous oxygen sparged into the tank.

Additionally, flocculant requirements have decreased on the free milling ore by approximately 10%.

**After - Optimized Thickener**
