FLEXIBLE, ECONOMICAL SOLUTION RETURNS AGEING FILTER TO OPTIMUM PERFORMANCE AT MMG ROSEBERY

When an operational filter reaches 30 years old at any site, it's a significant milestone. Built in 1987 and beset with premature wear, ageing parts, and recurrent corrective maintenance, the standard response might be to replace with a new filter. At MMG Rosebery,

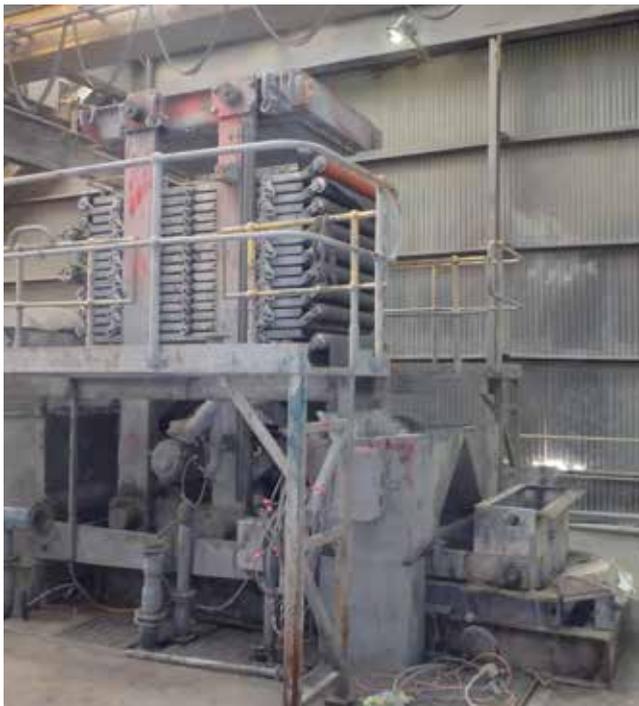
Plate pack ready for strip down.

As part of the scope, Outotec provided advisory services to oversee the filter rebuild. Two Outotec filter experts arrived 13 March 2018 just prior to site outage. They met with the Rosebery team to identify safety hazards and finetune the filter refurbishment plan. Once the filter was stripped down and all unusable parts removed, the refurbishment of the filter began.

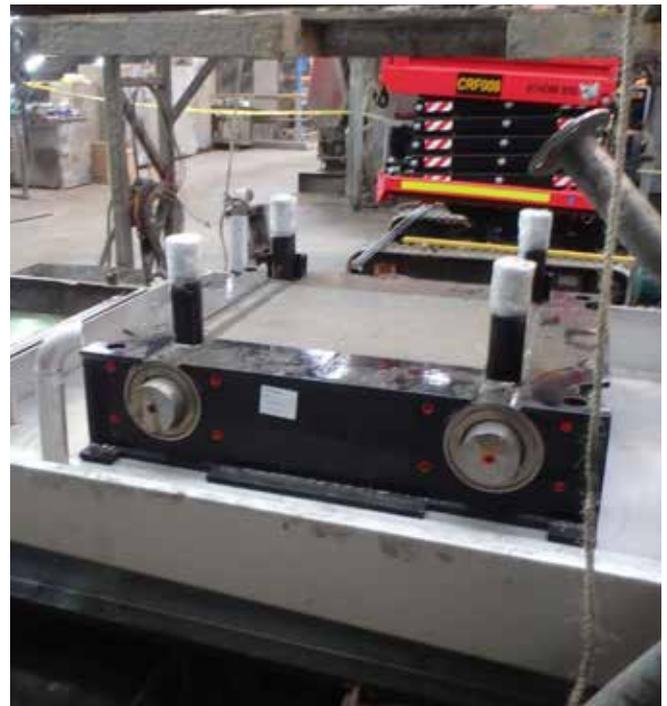
Foundation part installed and levelled.

New components included the plate pack, top and bottom pressing plates, foundation plate, filter base frame, pinch/butterfly valves, process feed/filtrate and pressing water hoses, cloth wash spray bars, cloth wash filter strainer, cloth tensioning unit and cloth drive unit.

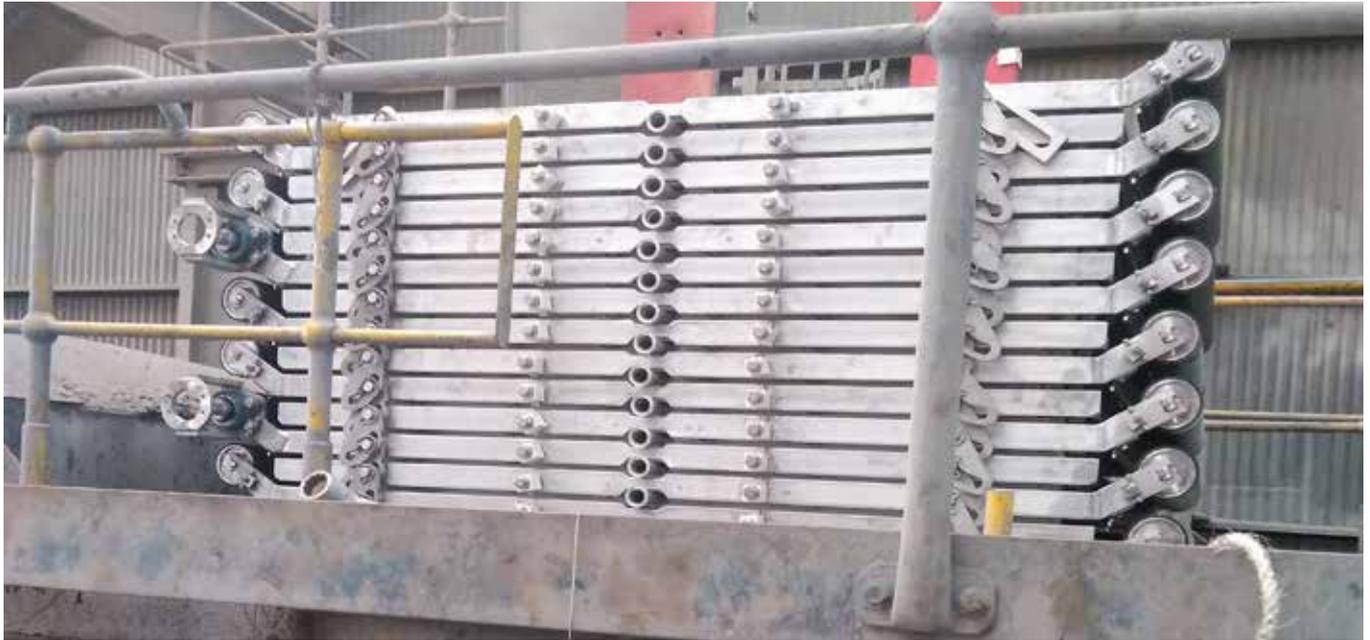
Filter plates assembly work in progress.

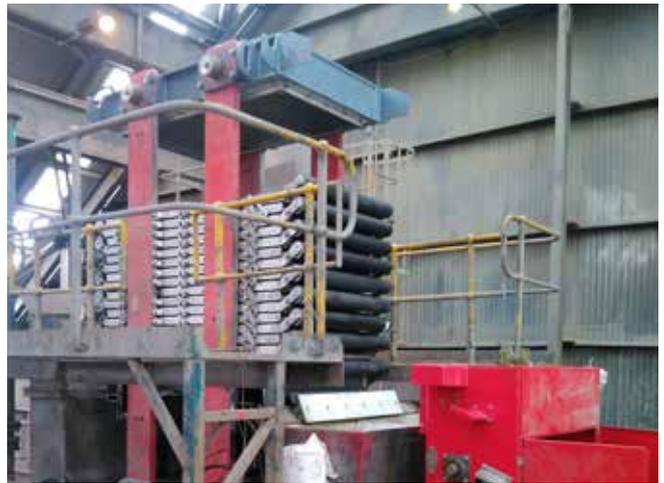
Top pressing plate installed.
