OUTOTEC® POLYMER HSB TECHNOLOGY HELPS CUSTOMER AVERT BALL MILL BEARING FAILURE

Bearing failure and significant ball mill damage avoided due Polymer HSBs at customer site

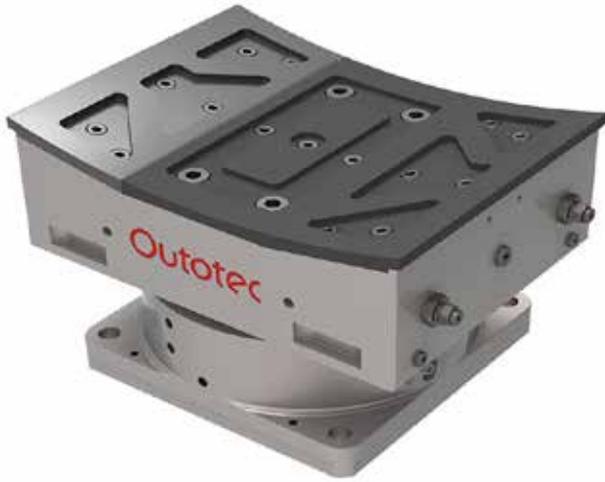
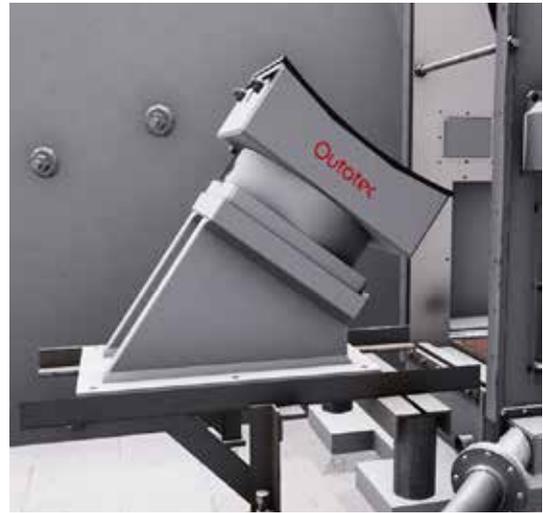
The Polymer HSB system's state-of-the-art self-aligning capability ensures that the pads are always precisely aligned with the mill journal. This facilitates best-in-class load measurement using bearing pressure and ensures bearing loads are evenly distributed across the mill journal.

The self-aligning capability is achieved through detailed design of the bearing oil galleries and an oil pressure supported spherical bearing. This optimised design provides both unparalleled flexibility for the bearing to align with the journal as well as automatic real time adjustment of the alignment.

The oil gallery and distribution setup are maintenance free and require no adjustment over the lifetime of the mill. The polymer bearing surface is extremely robust and offers self-lubricating properties, allowing operational excursions such as bearing to journal contact or oil contamination, without damage to the bearing or mill journal.
